**USAAMRDL TECHNICAL REPORT 71-65**  
**EVALUATION OF**  
**SELF-SEALING BREAKAWAY VALVES**  
**FOR**  
**CRASHWORTHY AIRCRAFT FUEL SYSTEMS**

By  
**Bruce Anson**

**November 1971**

**CONTRACT DAAJ02-70-C-0038**  
**DYNAMIC SCIENCE ENGINEERING OPERATIONS**  
**A DIVISION OF MARSHALL INDUSTRIES**  
**PHOENIX, ARIZONA**

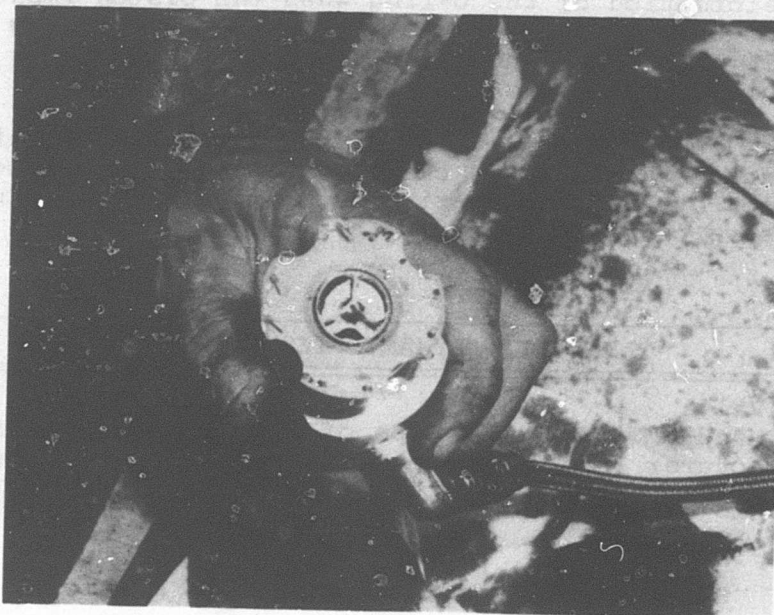
Figure 25. Valve 3 After Tensile Test.  
(Note Extruded O-Ring).

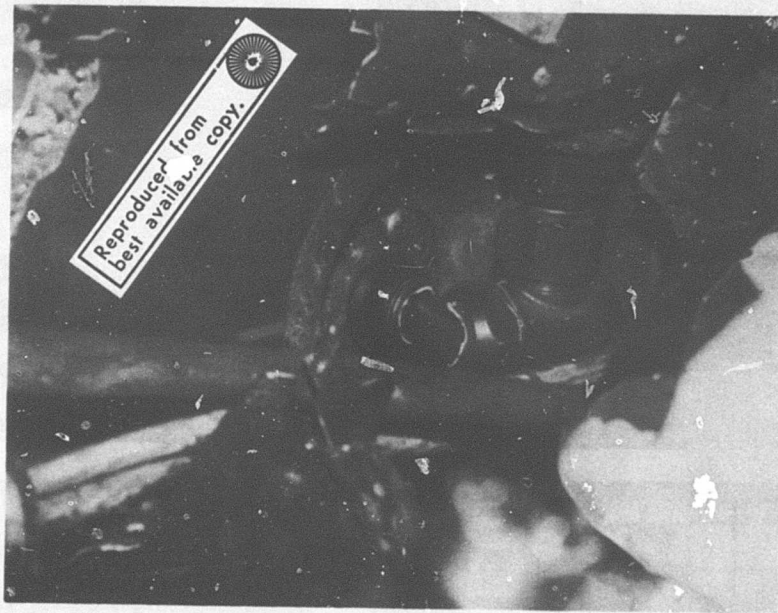
Figure 47. Illustration of Partial Separation Occurring in a Simulated Full-Scale UH-1D/H Helicopter Crash.

Partial separation, a condition defined as separation of the valve body outer housing prior to complete separation of the valve into two distinct halves, has been shown to be a significant problem area associated with the majority of present designs. Figure 47 shows a valve partially separated in a full-scale test after the test helicopter was subjected to simulated crash conditions.
